Save Our Special Ceiling Project at St Michael's Church, Brent Knoll

Some illustrations of our project from July 2019 to Sept 2020

During early 2019 we worked with our architect to develop a Schedule of Work built around the needs of our Quinquennial Report of 2015. The main work was to re-lead the N aisle roof which was leaking. The Schedule included subsidiary work on repointing and conserving masonry and repair of iron work on our windows:

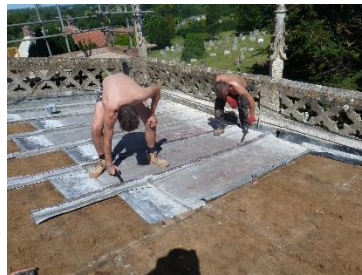
Stripping the remaining lead...

When roof work began on 20th July the foreman of building work reported a potential issue with lead replacement covering the guttering draining the roof. In essence the original plan to re-lead the roof could potentially cause problems years ahead because the lengths of lead required to replace the established guttering were too long. Over long lengths of lead can split as a result of expansion and contraction with temperature variations. Owing to the concrete base the gutter could not be lowered, so, instead, it would have to be raised, which would then create problems with the inclination of the main roof. As it was constructed the angle of the roof was at 10 degrees, which is the minimum angle permitted under Lead Sheet Association guidance for overlapping rolls of lead. The proposed solution was to introduce a step into the roof which would avoid the need to overlap rolls of lead. The downside of this solution was that it would mean a considerable amount of preparatory timberwork before the lead was to be laid. The Parish accepted the solution and work began in earnest later that week...

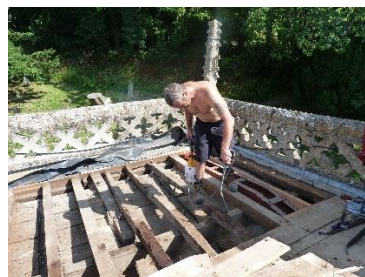
and underlying wood is treated

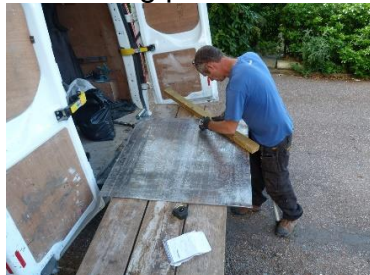
Marking up the lead sheet

Lead is malleable. It can be cut and moulded to construct items for particular parts of the roofing process. Lead sheet is marked up, cut and then welded.

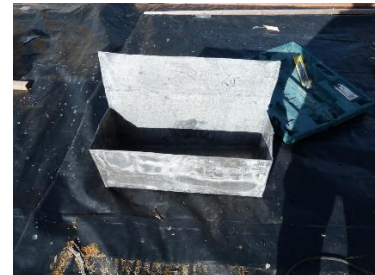
A finished product – a gutter sump

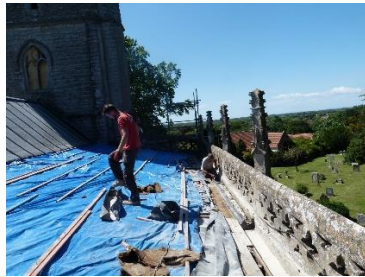
Overlength gutter being removed

Gutters require that water should flow and that there are collection points for the water to run out clear of the building. Under the revised roofing plan the gutter had to be raised and stepped to ensure that it was possible for the water to drain through spouts that throw water clear of the walls.

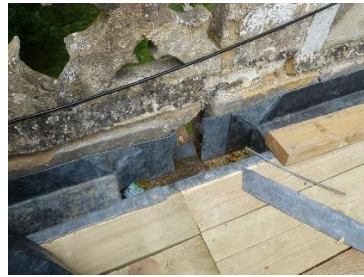
Gutter sump in position

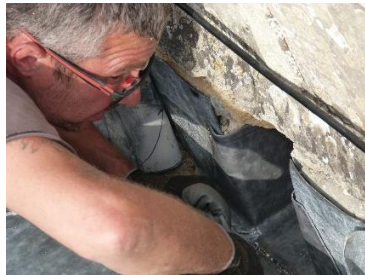
Sump/spout welds being cleaned

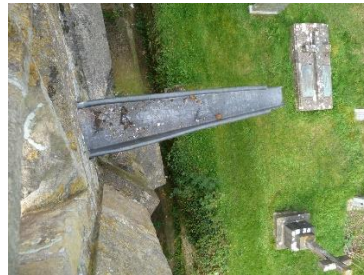
Water spout in position

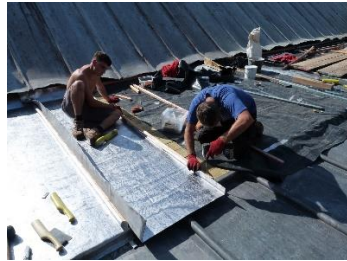
Fixing the mopstick in place

General covering of the roof is achieved by installing bays in sections. The lead is first painted with a chalk emulsion to protect the lead that is then laid on a vapour barrier of builder's paper. The lead is then fashioned into a "bay box" that is laid in position. Finally the box is hammered into shape with an overlap to the roll that covers a wooden stick (the mopstick). This method of laying lead is known as "closed roll".

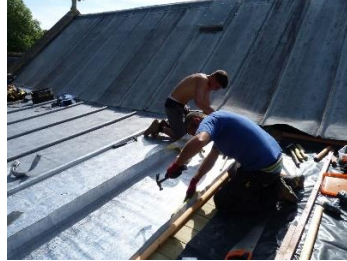
Hammering the lead into position

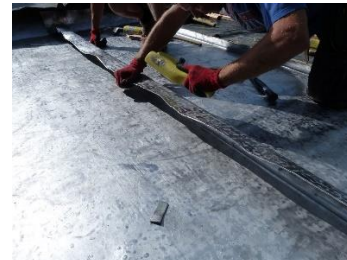
Hammering the lead down

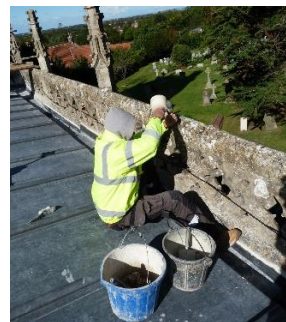
Raking out old mortar

Lime mortar has to be used for repairs to Grade 1 listed buildings. This type of mortar does not contain cement, which modern mortar mixes do. Unlike cement-based mortars, lime mortar takes weeks to set and months to finally “cure”. There are two ways in which it was used in our project:

- The lead flashing that is chased along the north aisle parapet
- To repair significant cracks in the masonry of the parapet and turret.
