THE BENCHENDS

A selection of the carved benchends

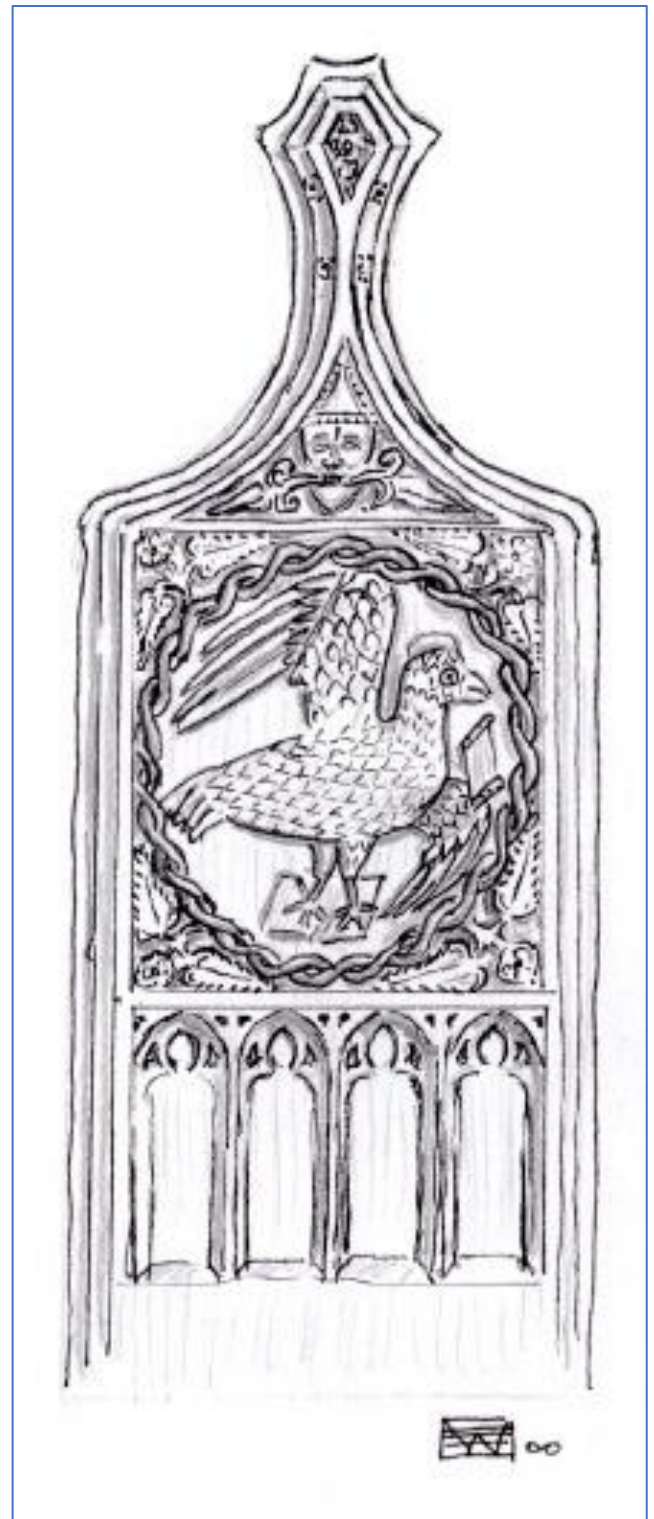
3. Eagle. Various symbols were used to represent the four evangelists, three of the most common are found in St. Michael's. St. John is depicted as an eagle, here set in a twisted wreath, with a book in his claws and a scroll supported by his lower wing. Comparing the wings used for this eagle, with both pious pelicans and some of the birds in the fox and goose trilogy, clearly demonstrates that they were carved by the same person. Other features, such as feathers, feet and tails, and sometimes even beaks (though that does change between bird species), are almost identical, enhancing that belief. There is a difference between the main pious pelican panel and this eagle, in that the pelican has four feathers to the eagle's three, but even that fails to hold true for the smaller pelican panel, where the pelican only has three feathers. However, the way they hold their wings does differ substantially, for the pelican holds both wings aloft, whilst the eagle has one sweeping down to the ground. Another green man adorns the neck of this benchend, this time with a plain hat with dotted sides, which could well be another mitre. The poppy-head is foliate and roses decorate the spandrels, each with two pointed leaves, decorated at their edges.
